Flinders Ports Berth 6 and 7 Crane Rail Repairs

Client	McMahon Services
Location	Adelaide, SA
Value	\$280,000
Duration	Mar 2016 - Jun 2016

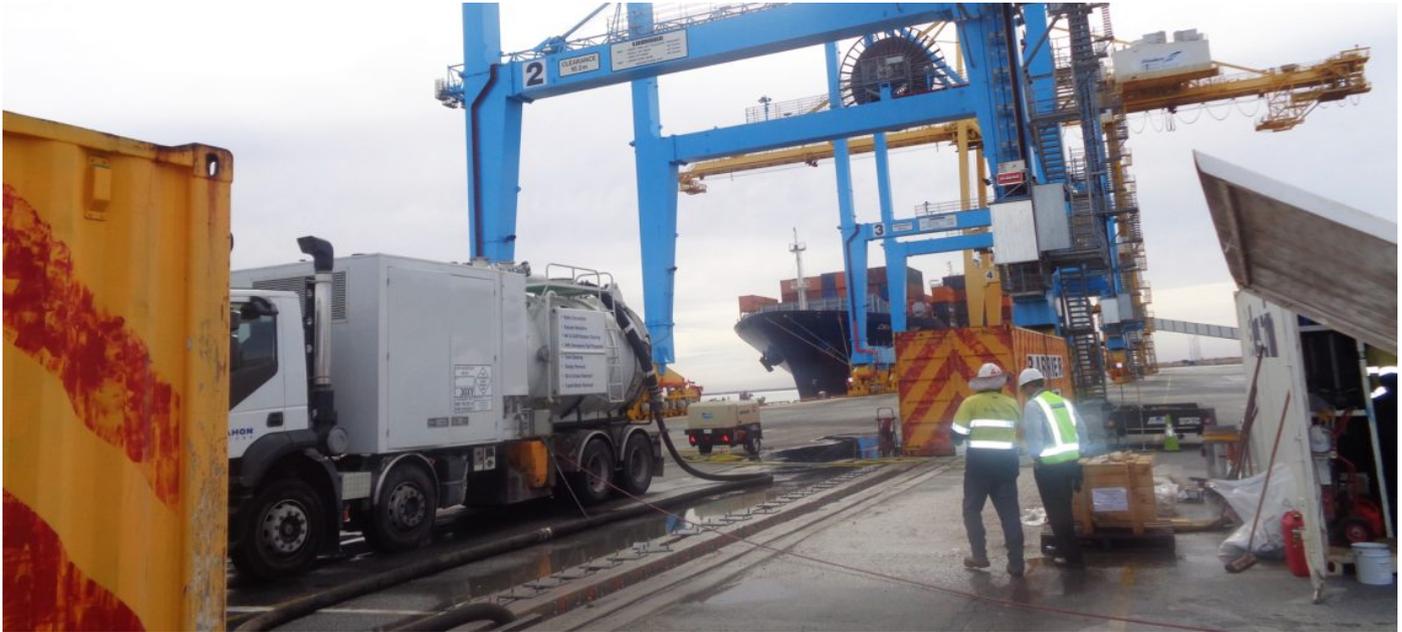
Following extensive condition surveys, Flinders Ports identified that approximately 96m of existing 86kg/m crane rail was showing signs of deterioration. McMahon Services were engaged by Flinders Ports to remove and replace eight 12m sections of existing crane rail. Following the successful delivery, Ballestrin were engaged to replace a further 60m of rail.

Works comprised of removing loose concrete and grout around the top portion of the rail to access the fixing bolts, cutting of the existing fixings and the crane rail section to suit the new replacement rail to a 12m section, and the removal of existing crane rail.

Ballestrin then cut down the remaining exposed bolts, and then set up new base plates to support the new crane rail, enabling easy replacement in the future. The next step was coring new fixing holes for holding down bolts and cleaning out holes followed by the installation of HD bolts and epoxy into position. Final levelling of the supporting rail base plates was achieved with levelling equipment. The new crane rail was installed. During high temperature events, the rail was subject to thermal expansion. In order to ensure a controlled member length rail sections were covered or cooled to control expansion and ensure new sections fitted correctly. The infill of epoxy grout had a fast set time in order to infill all voids around the underside of the crane rail.

Placement and compaction of bitumen occurred a few days after the epoxy had time to cure, and infill of the void between the level of the epoxy (at the base of the rail) and the existing pavement level was achieved.
