Fife Avenue Bridge Remediation

Client	City of Mitcham
Location	Adelaide, SA
Value	\$0.1 million
Duration	July 2019

Project Overview

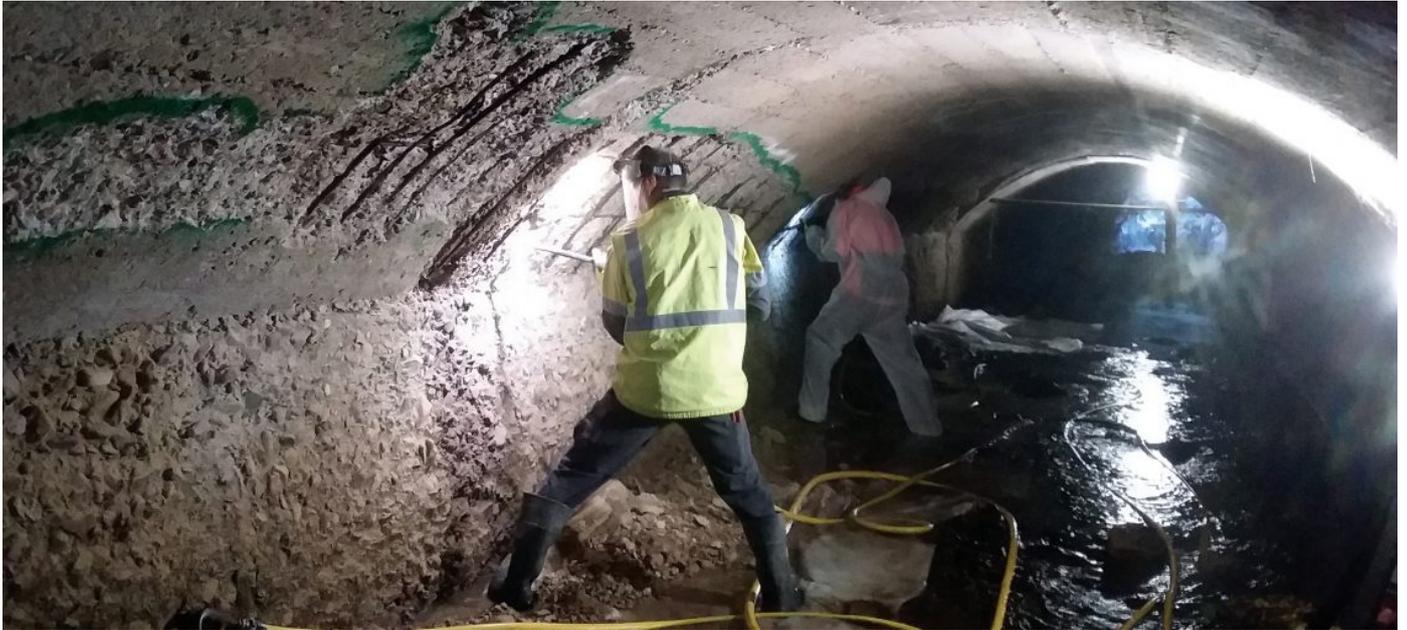
Fife Street Bridge is a road bridge in the Adelaide suburb of Torrens Park that crosses Brownhill Creek. The bridge was first constructed in 1936 and had suffered severe deterioration over time. Design consultants WGA acting on behalf of the City of Mitcham council had recently assessed the bridge and determined it required urgent concrete remediation works to prolong its structural design life.
